CAROLINA INFRASTRUCTURE ASSESSMENT LLC.  
STRUCTURES DIVISION

## Structure Safety Report

### Routine Element Inspection

| Superstructure: | STEEL STRINGER, TWIN GIRDER SINGLE SPAN BRIDGE W/ TIMBER DECK | | | | | |

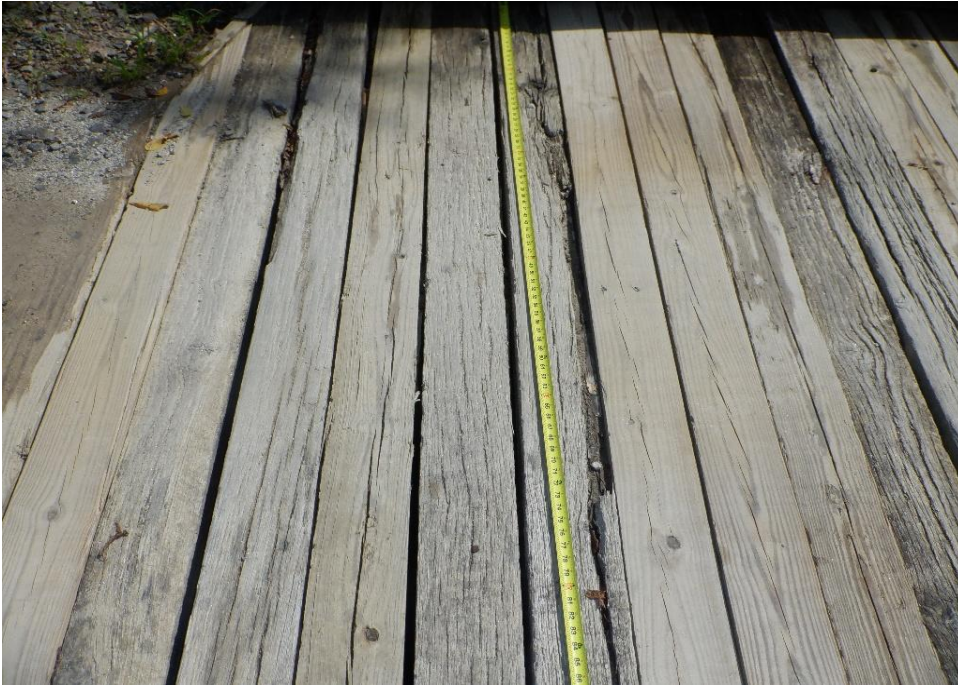
10' L AREA OF DECAY IN DECKING OVER END BENT 1

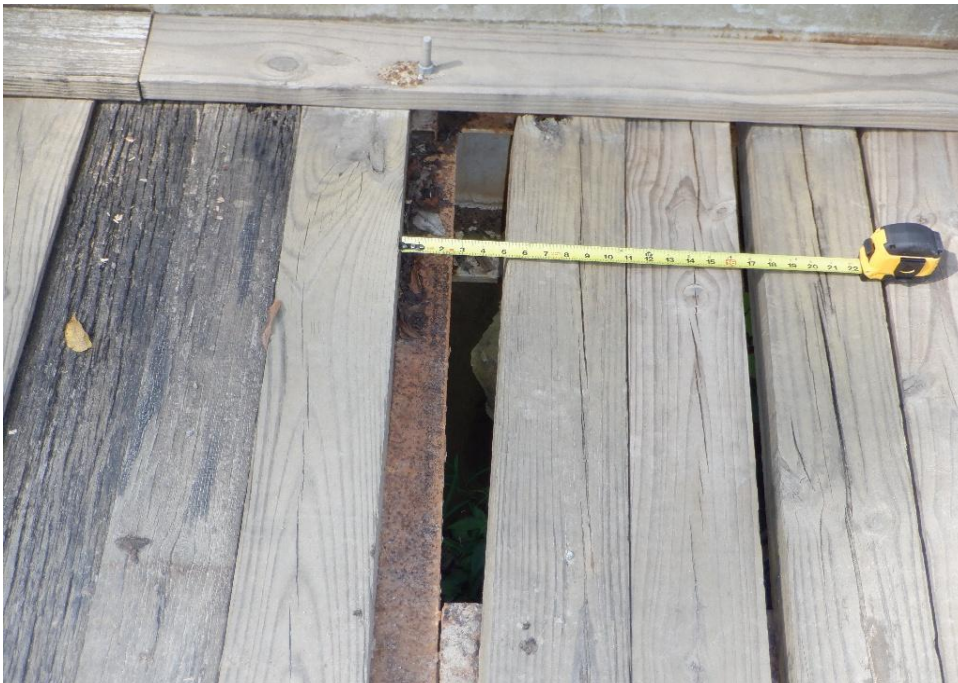
5.5" GAP IN DECKING OVER FLOORBEAM 3

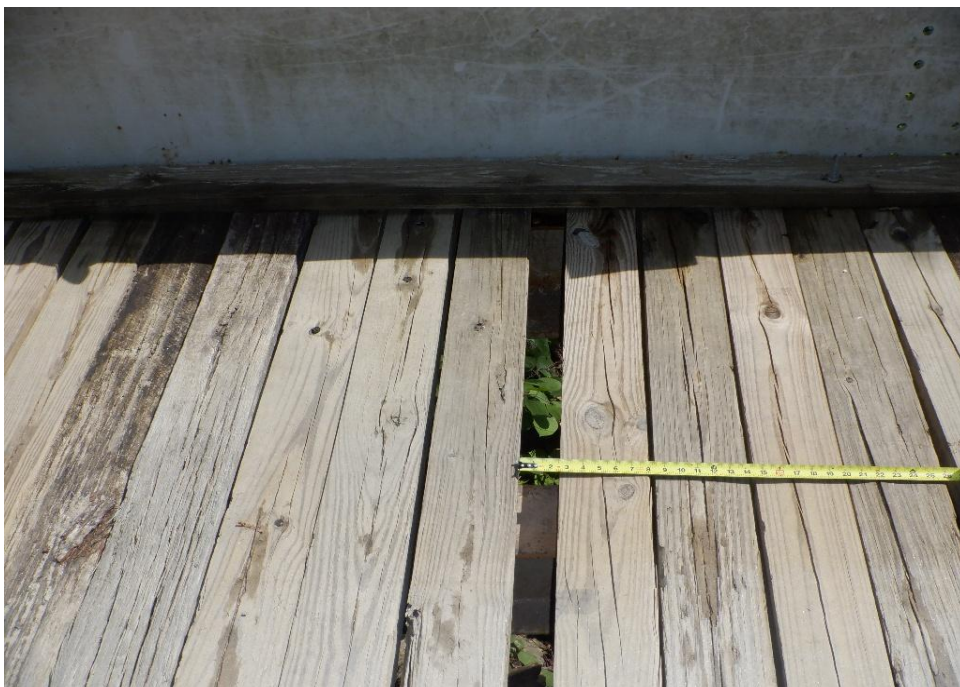
3" GAP IN DECKING BTW FLOORBEAMS 2/3

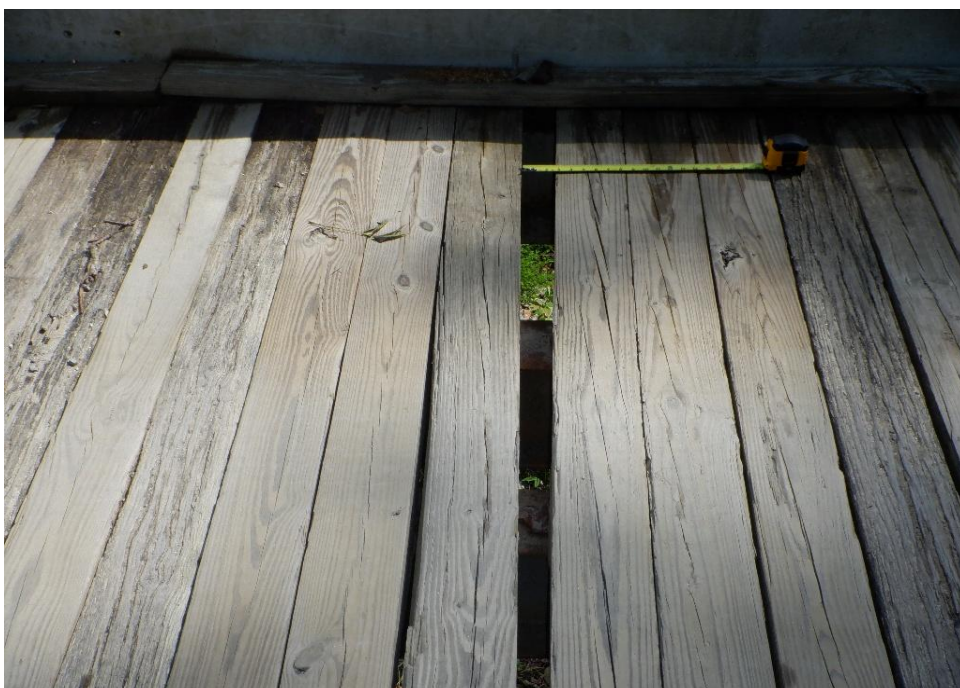
3" GAP IN DECKING BTW FLOORBEAMS 3/4

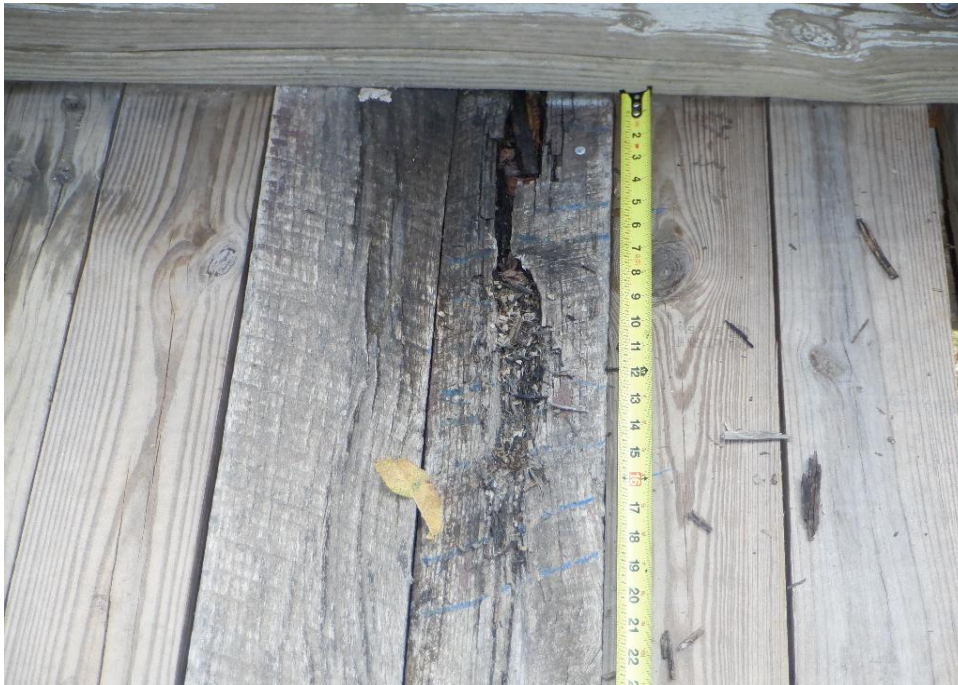
2' X 5.75" AREA OF DECAY IN DECKING N. END AT FLOORBEAM 4

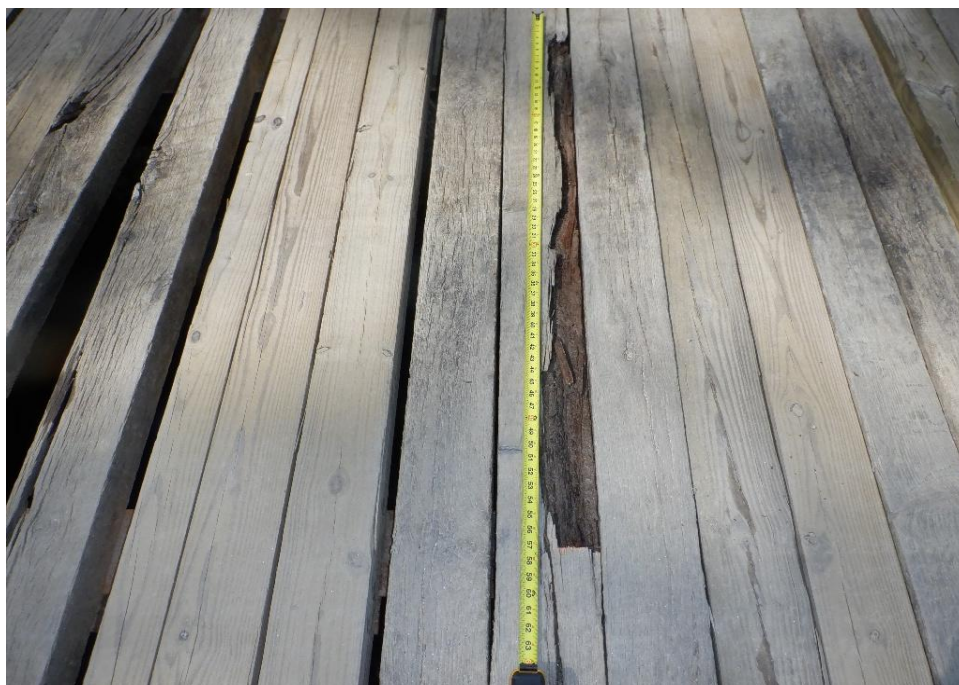
5' AREA OF DECAY IN DECKING BTW FLOORBEAM 5/6

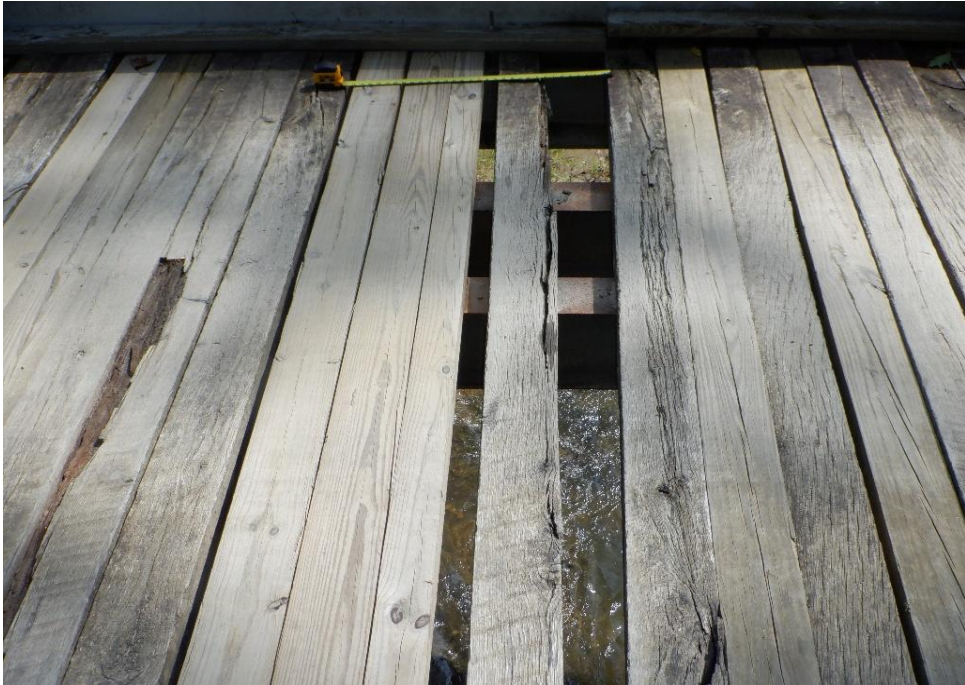
MISSING DECKING BTW FLOORBEAM 5/6

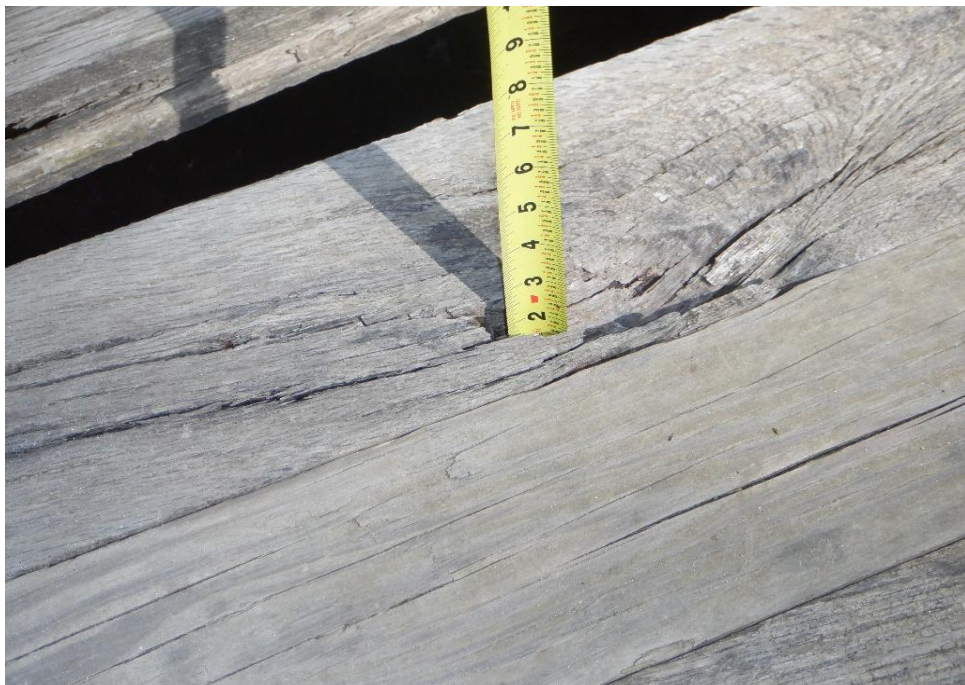
2" DEEP AREA OF DECAY IN DECKING BTW FLOORBEAM 5/6

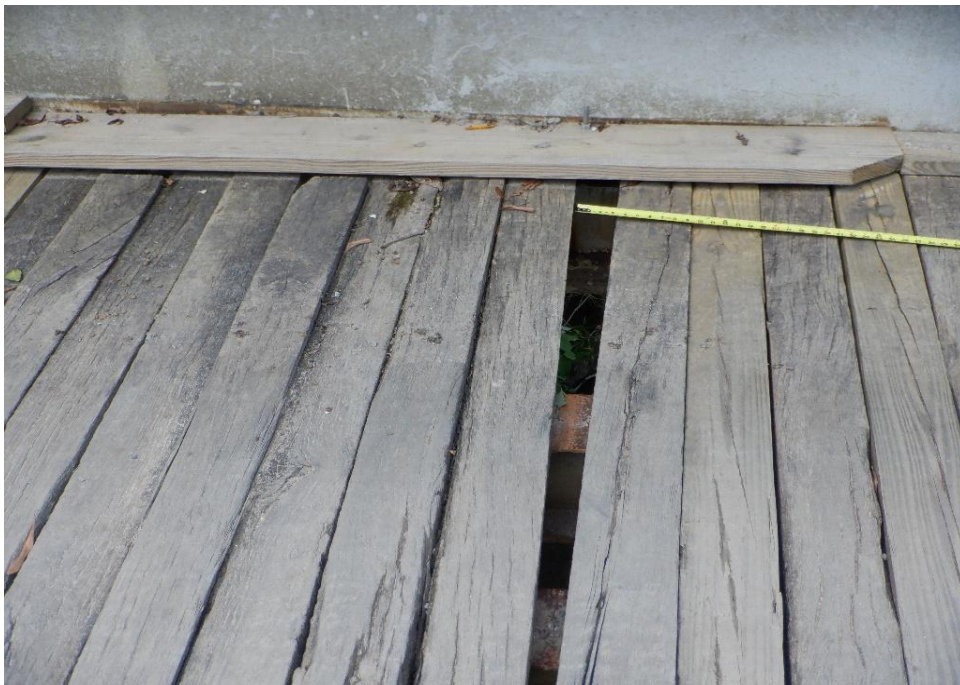
4" GAP IN DECKING OVER FLOORBEAM 6

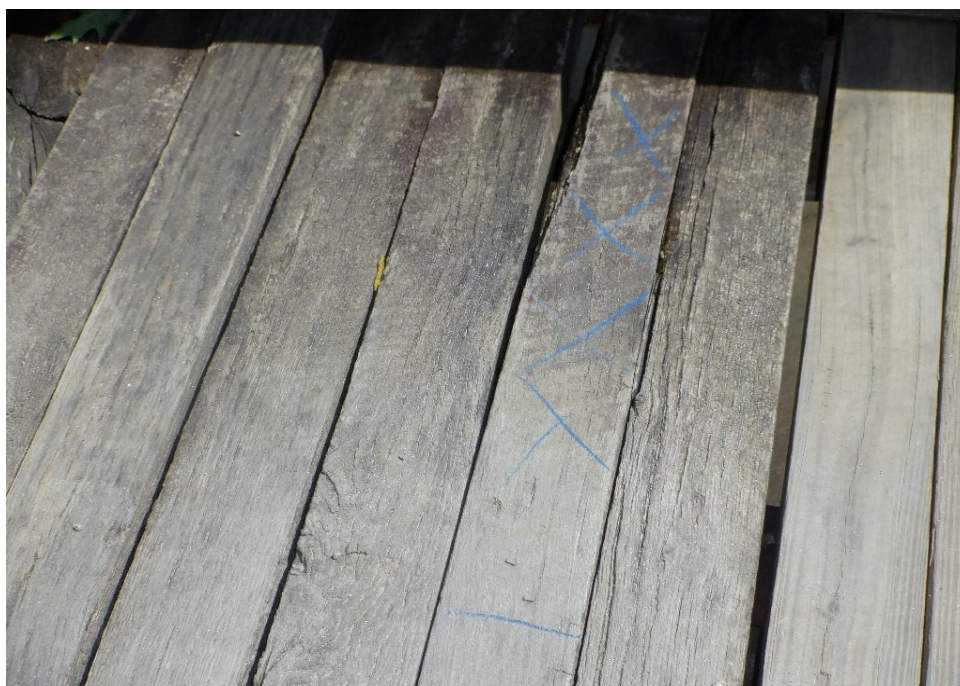
3' L DECAY IN DECK BOARD BTW FLOORBEAM 6/7- NORTH SIDE

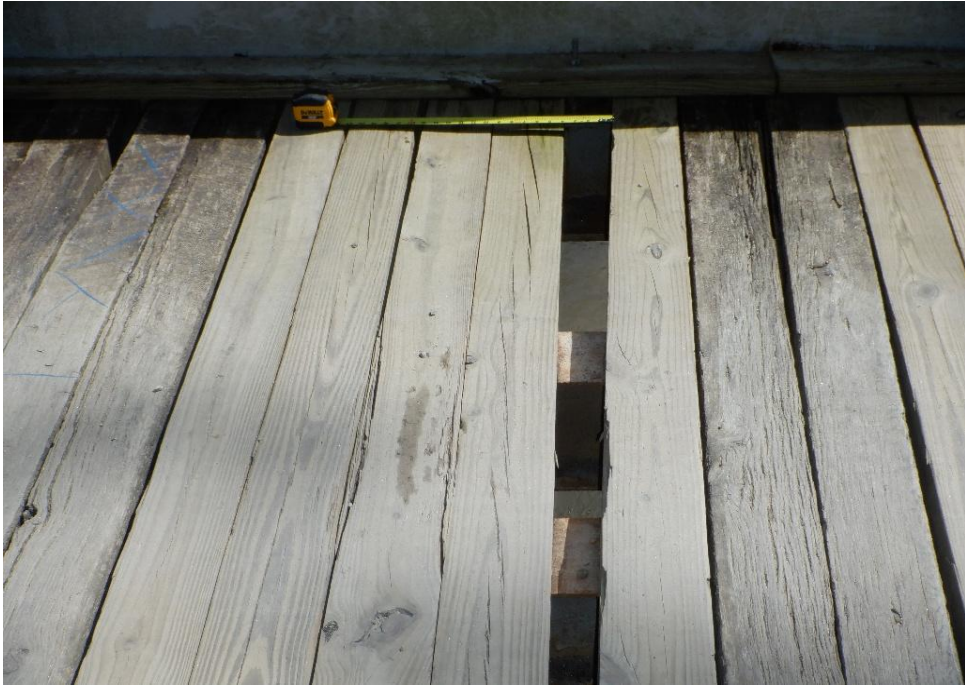
4" GAP IN DECKING BTW FLOORBEAM 6/7

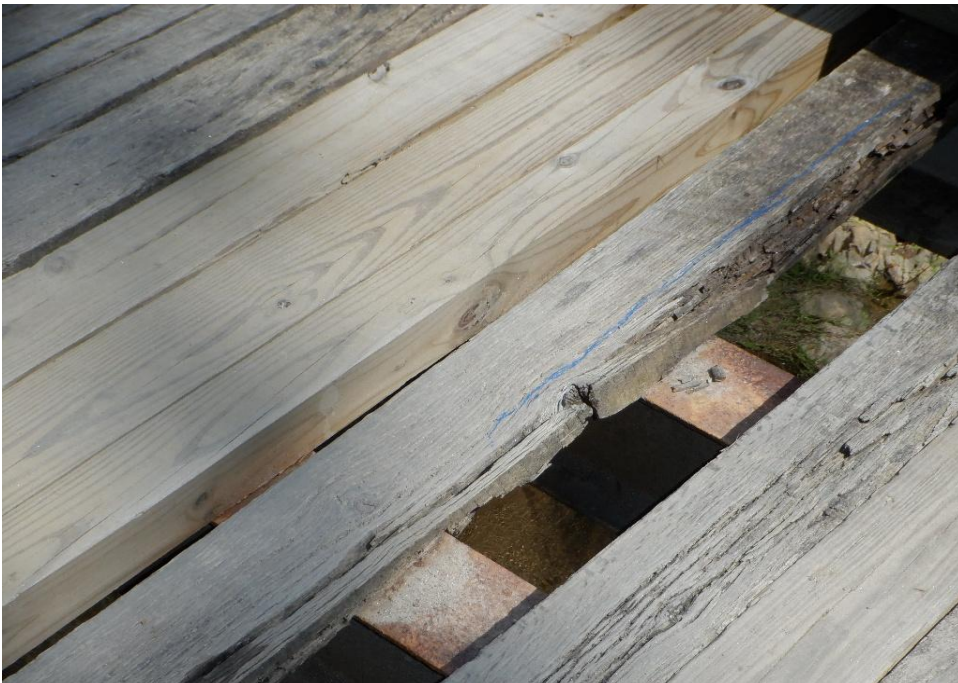
6' L AREA DECAY BTW FLOORBEAM 5/6

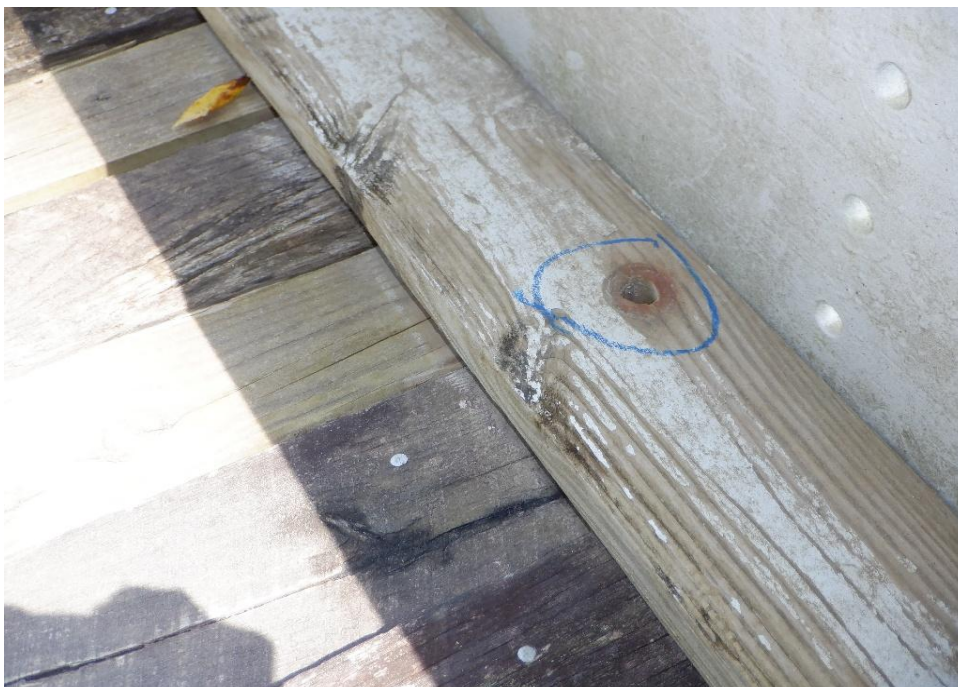
1 MISSING BOLT @ WHEEL GUARD N. SIDE AT FLOORBEAM 6

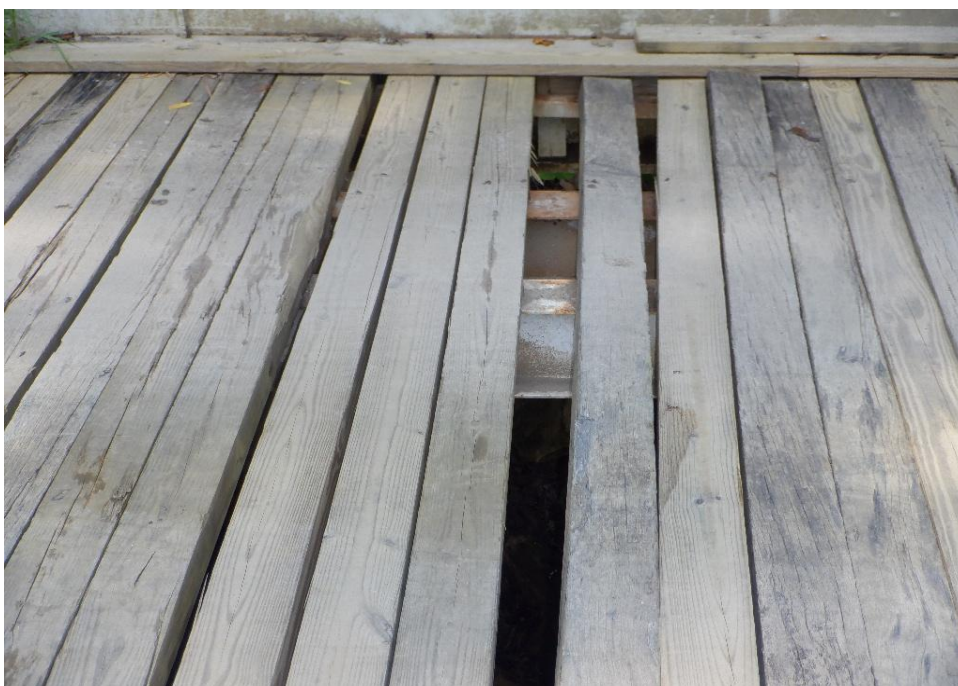
MISSING DECKING BTW FLOORBEAM 7/8 AT FLOORBEAM 8

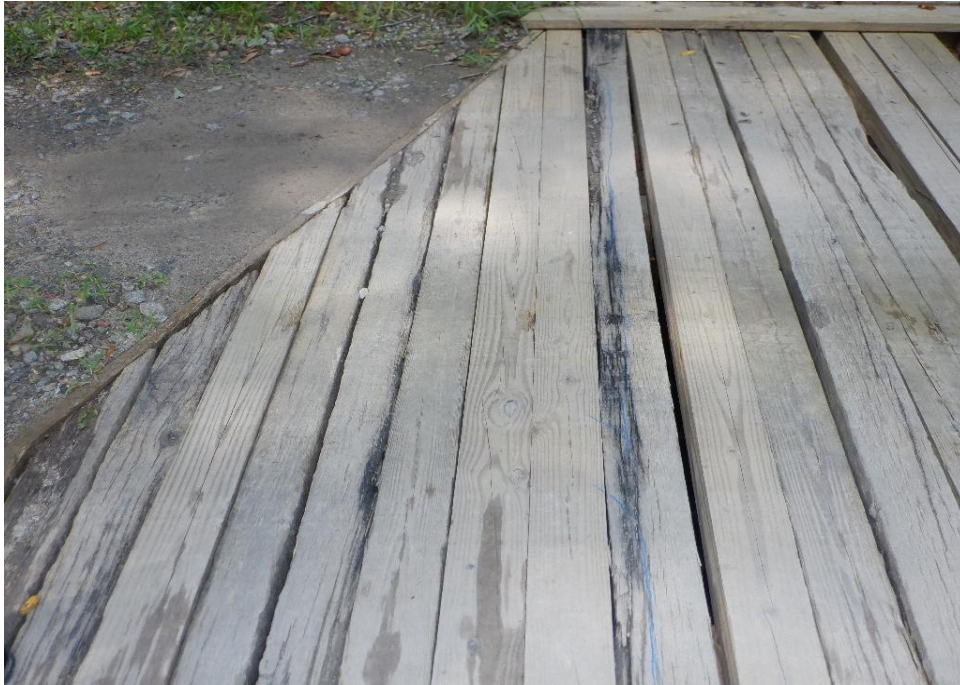
9' L AREA DECAY AT END BENT 2 BTW FLOORBEAMS 8/9

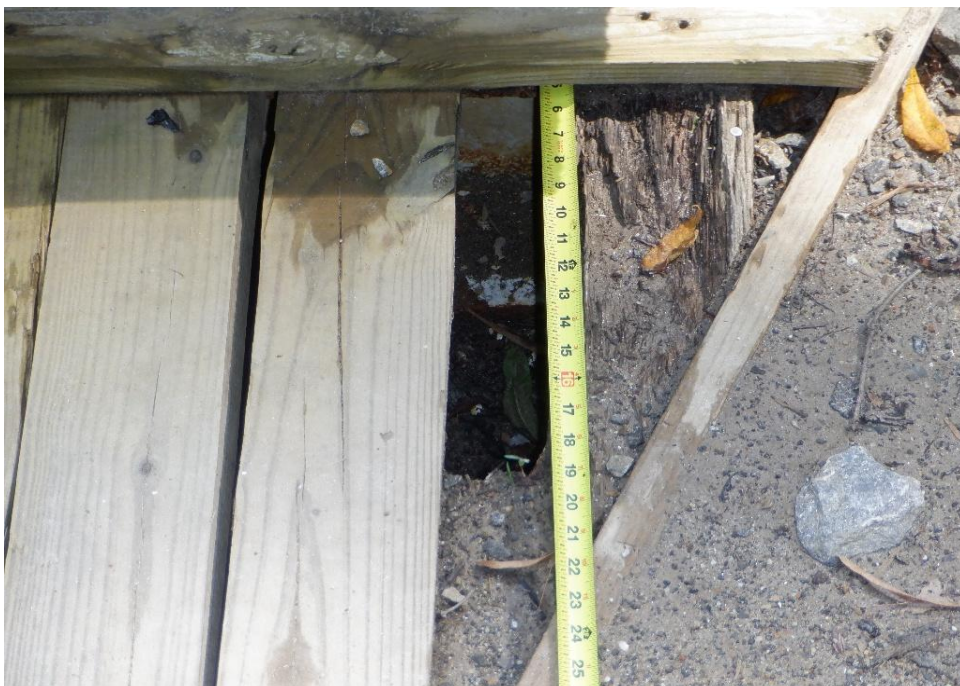
2' L AREA DECAY IN DECKING N. SIDE OVER END BENT 2

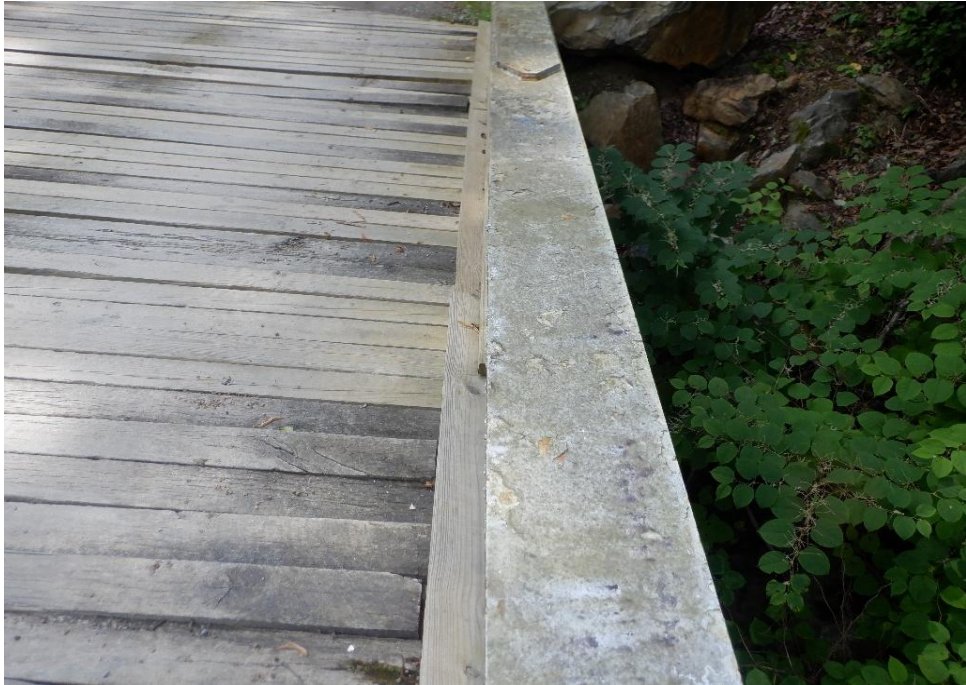
PROTECTIVE COATING FAILURE THROUGHOUT TOP FLANGE GIRDER 2

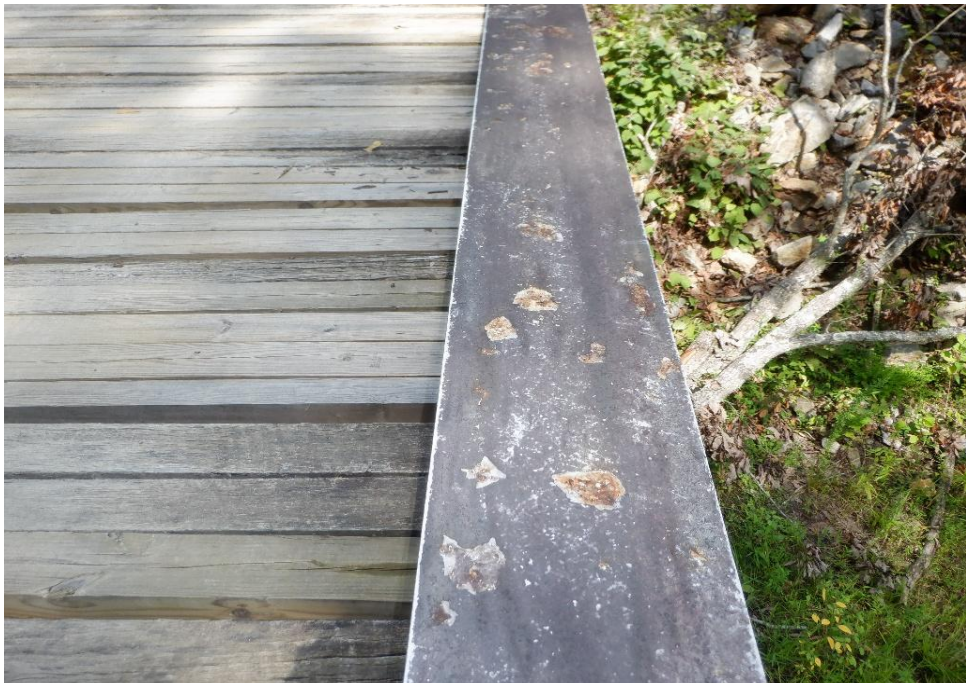
PROTECTIVE COATING FAILURE THROUGHOUT TOP FLANGE GIRDER 1

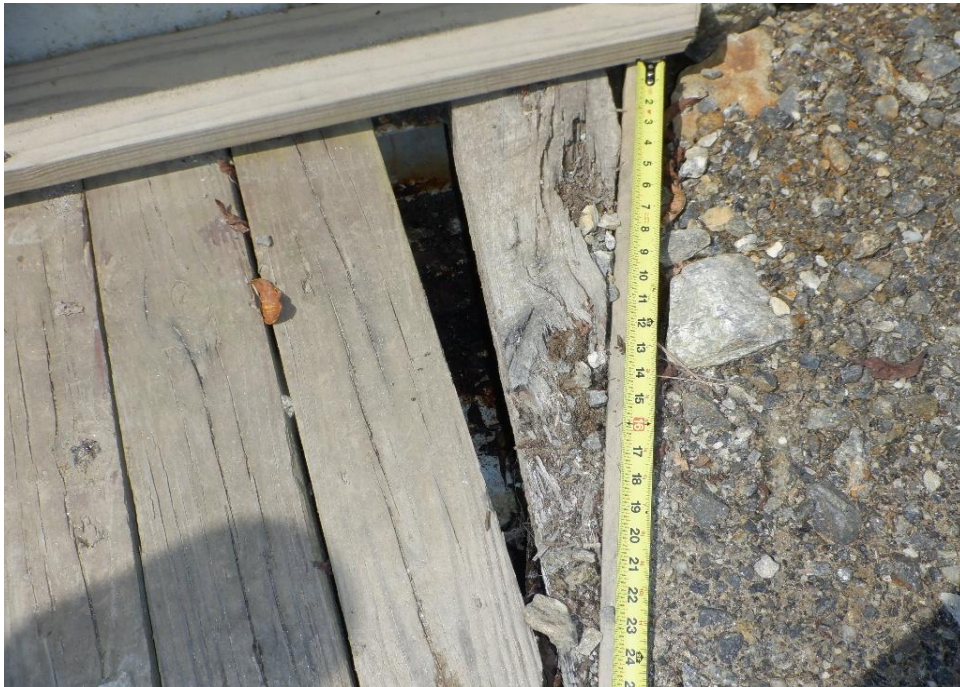
2' AREA DECAY IN DECKING OVER END BENT 1 SOUTH SIDE

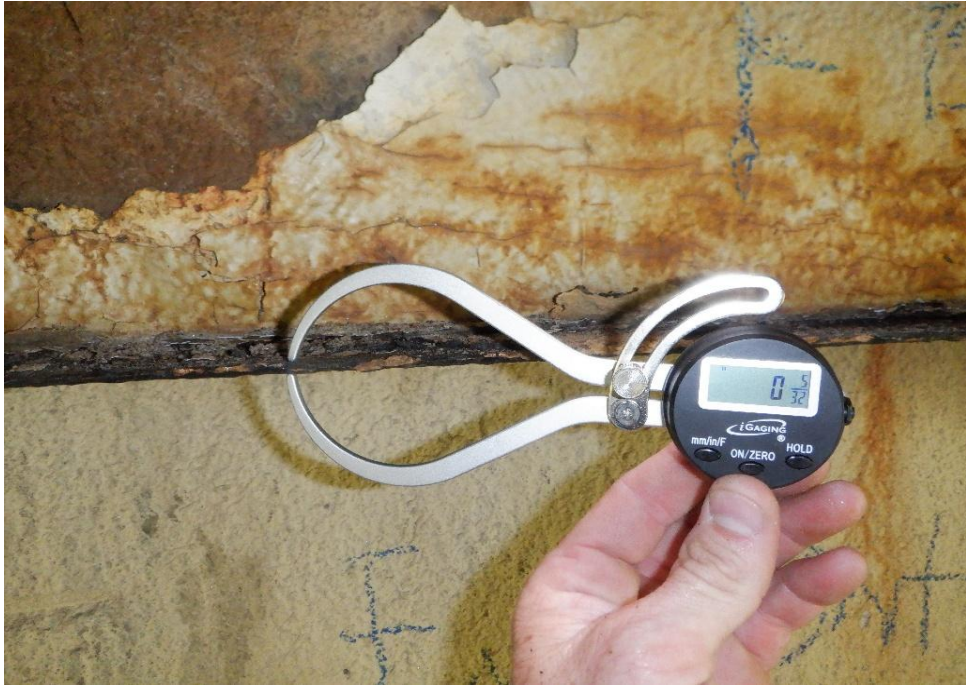
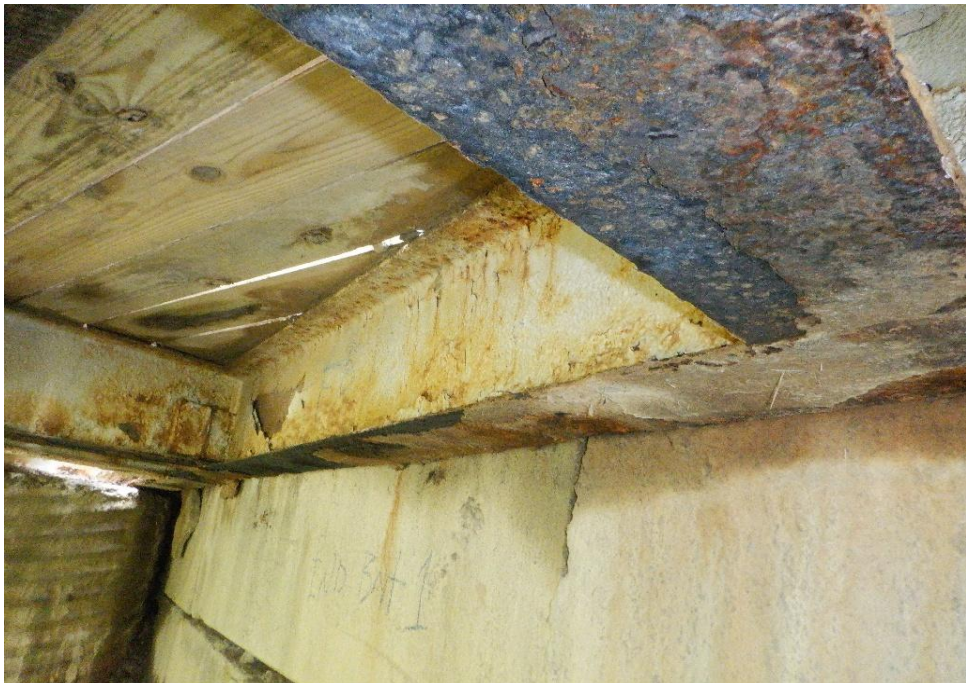
FLOORBEAM 1- 7/32" REMAINING 10' SECTION BOTTOM FLANGE

ALT. VIEW- 7/32" REMAINING BOTTOM FLANGE FLOORBEAM 1

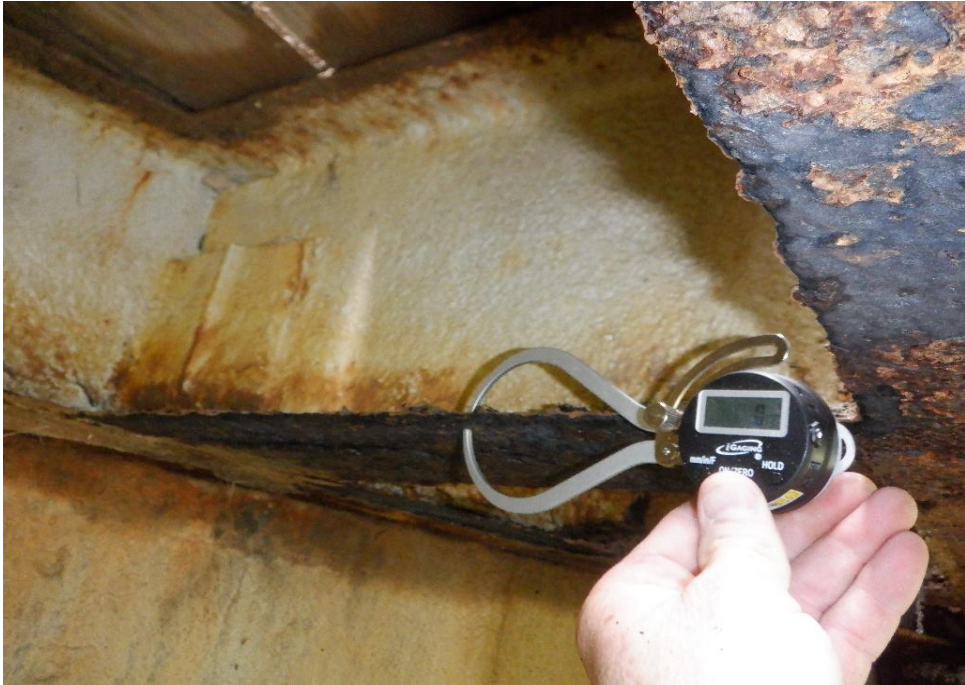
STR 2 @ END BENT 1- 1/64" REMAINING 2' SEGMENT BOTTOM FLANGE

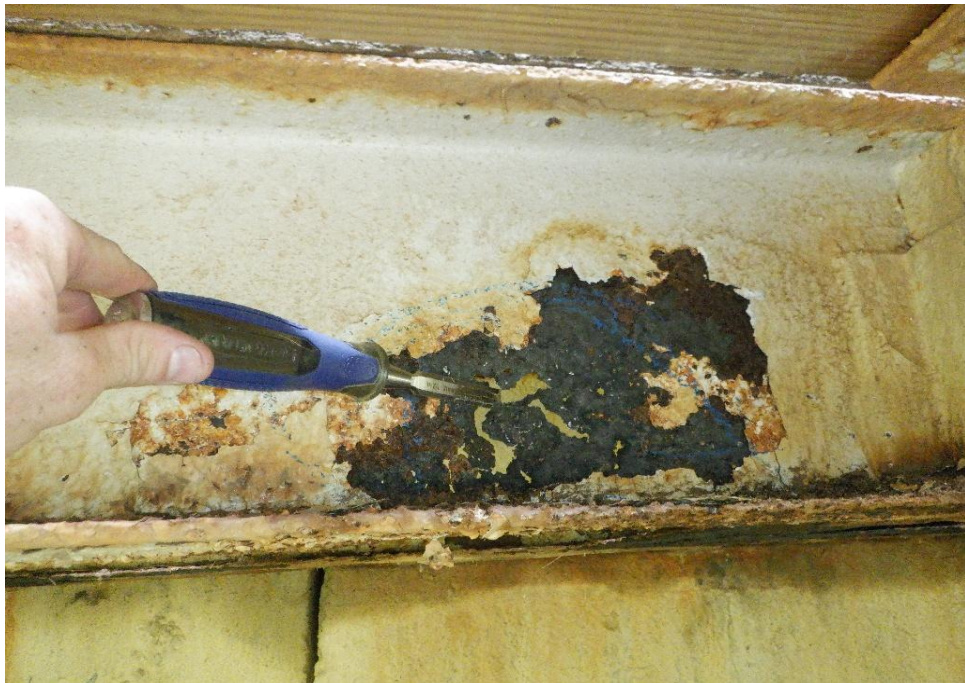
FLOORBEAM 2- 5" HOLE BTW STR 2/3

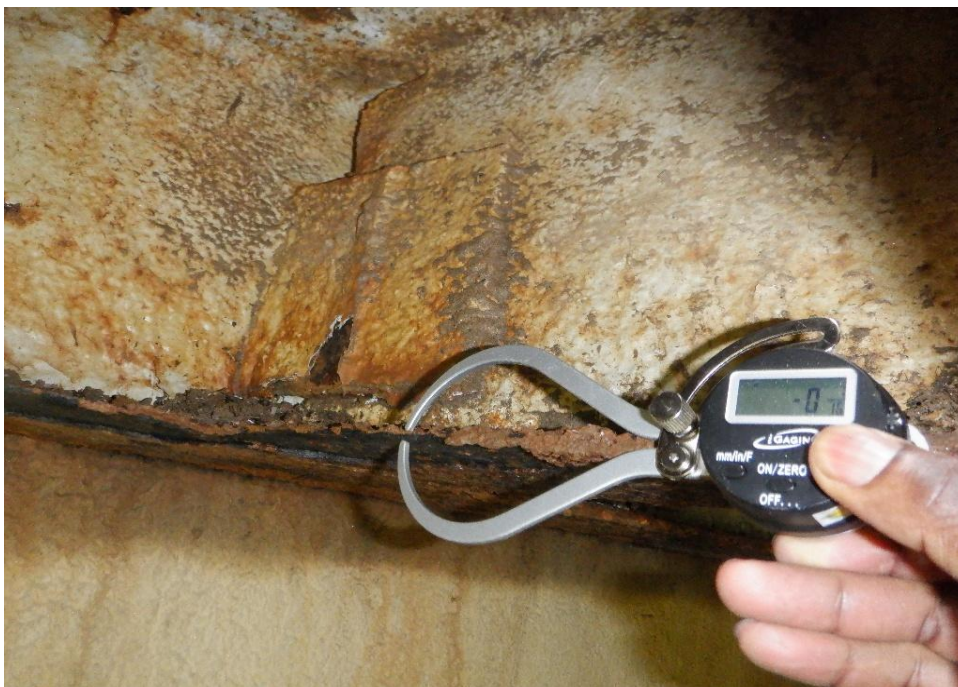
STR 1 @ END BENT 1 1/16" REMAINING BOTTOM FLANGE 2' SEGMENT

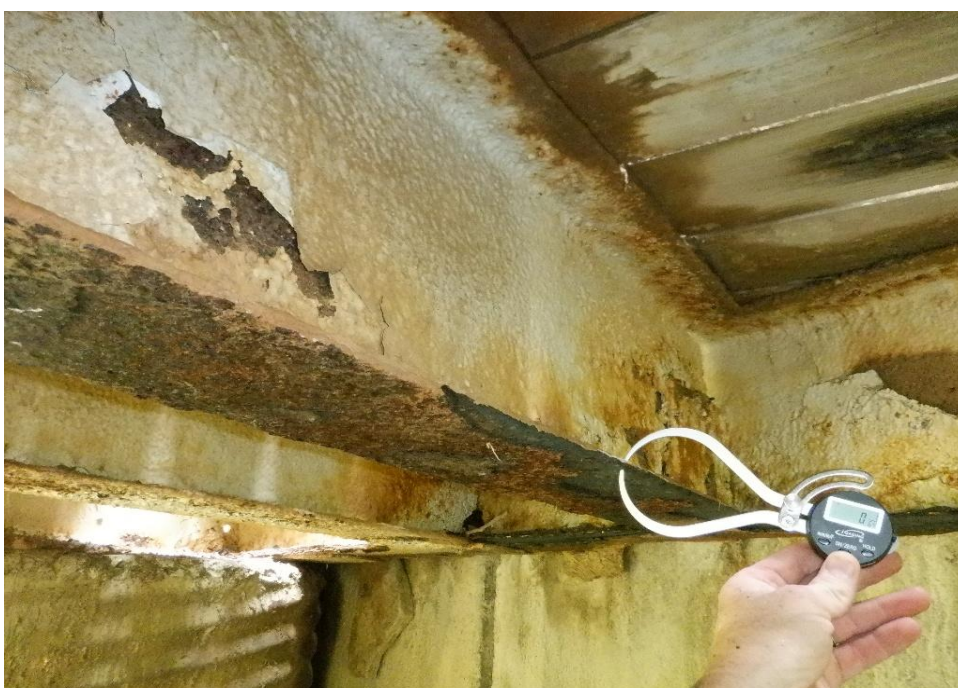
STR 3 BTW FB 1/2- 1/64" REMAINING TO BOTTOM FLANGE 3' SEGMENT

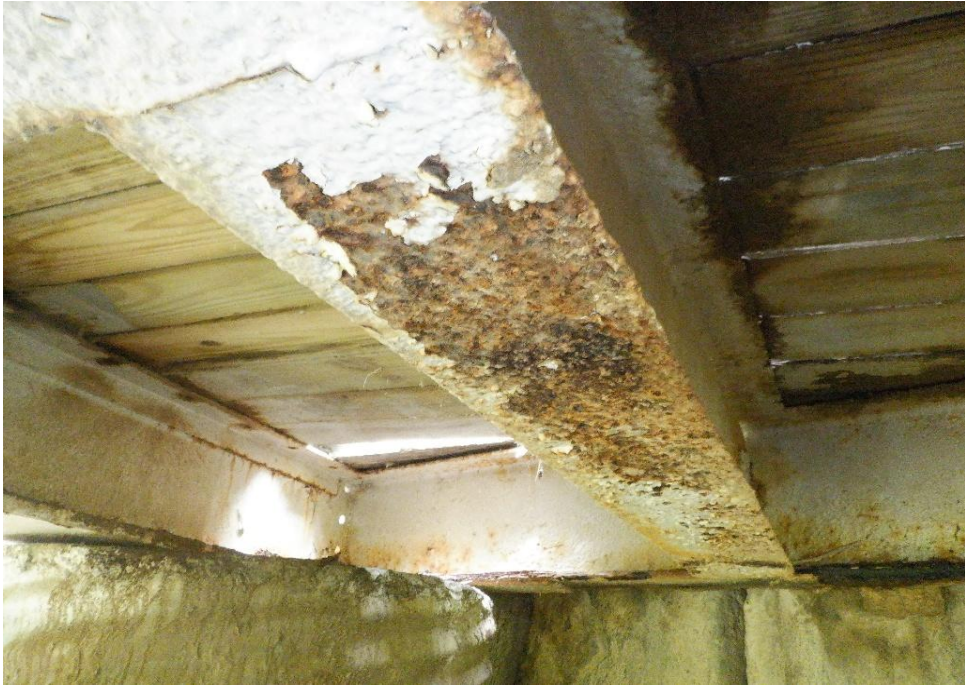
STR 4 1/8 DEEP PITTING BOTTOM FLANGE 4' SEGMENT BTW FB 1/2

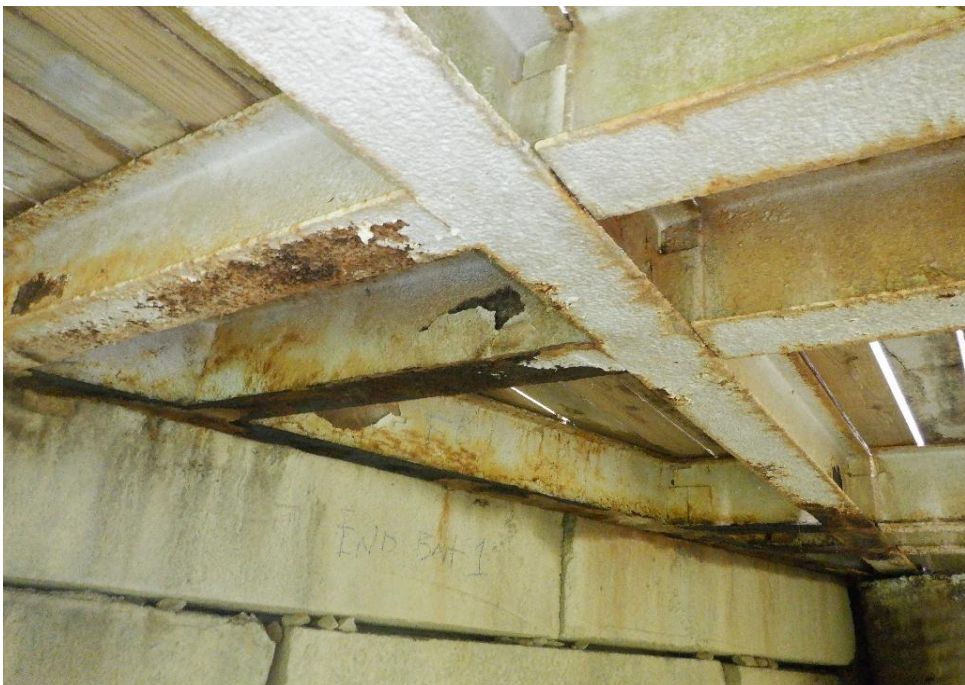
FB 1/2- PC FAILURE/CORROSION THROUGHOUT FB 1/2 BTW STR 1-4

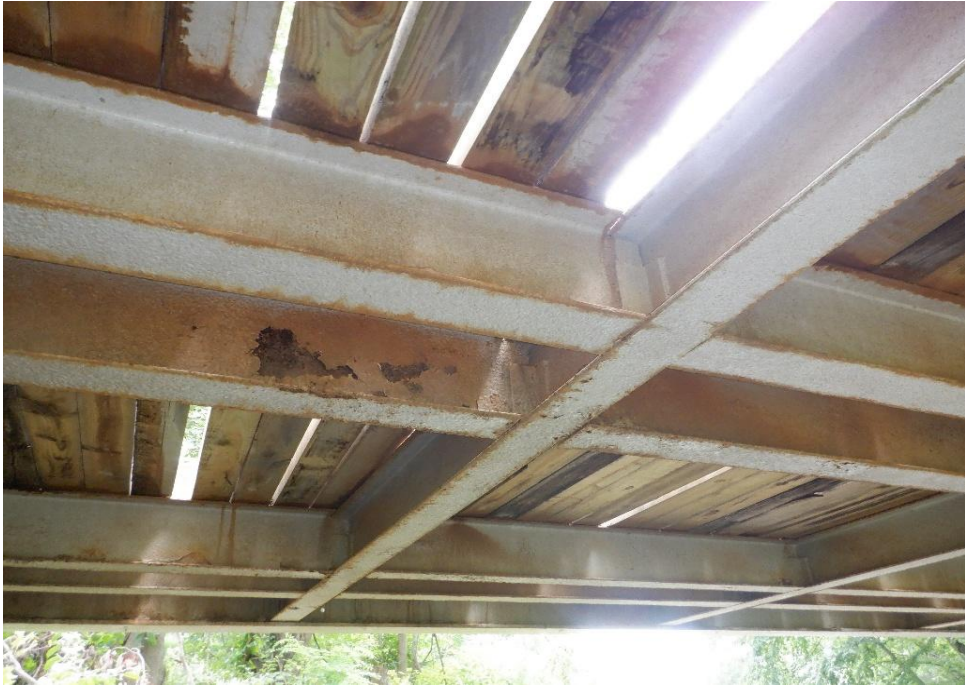
FB 3- RUST/BLEED THROUGH - PC FAILURE W/ CORROSION PRESENT

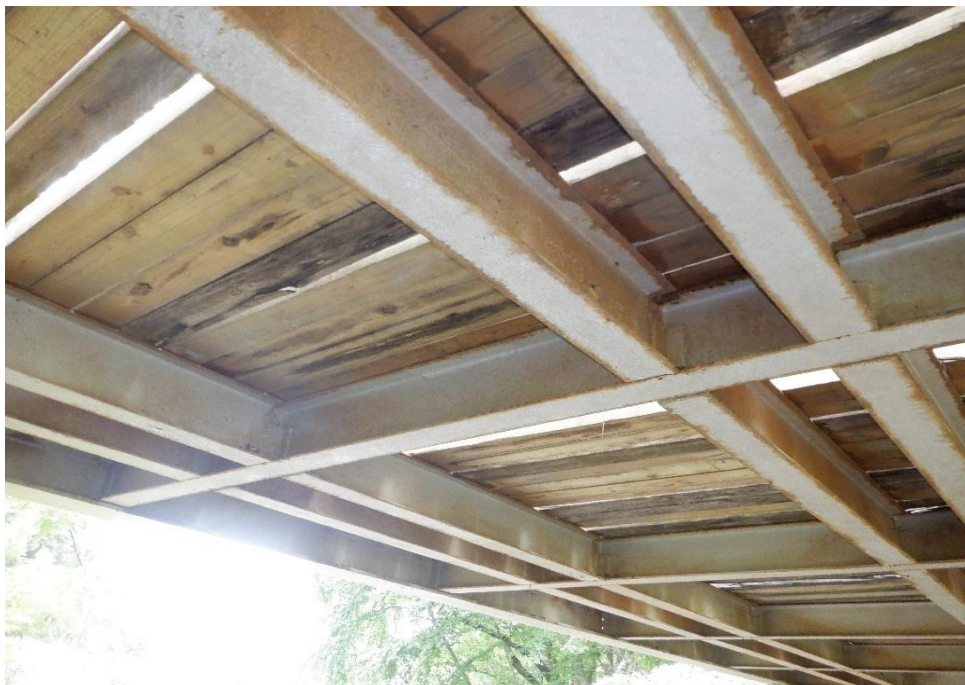
FB 4- PC FAILURE THROUGHOUT W/ CORROSION PRESENT

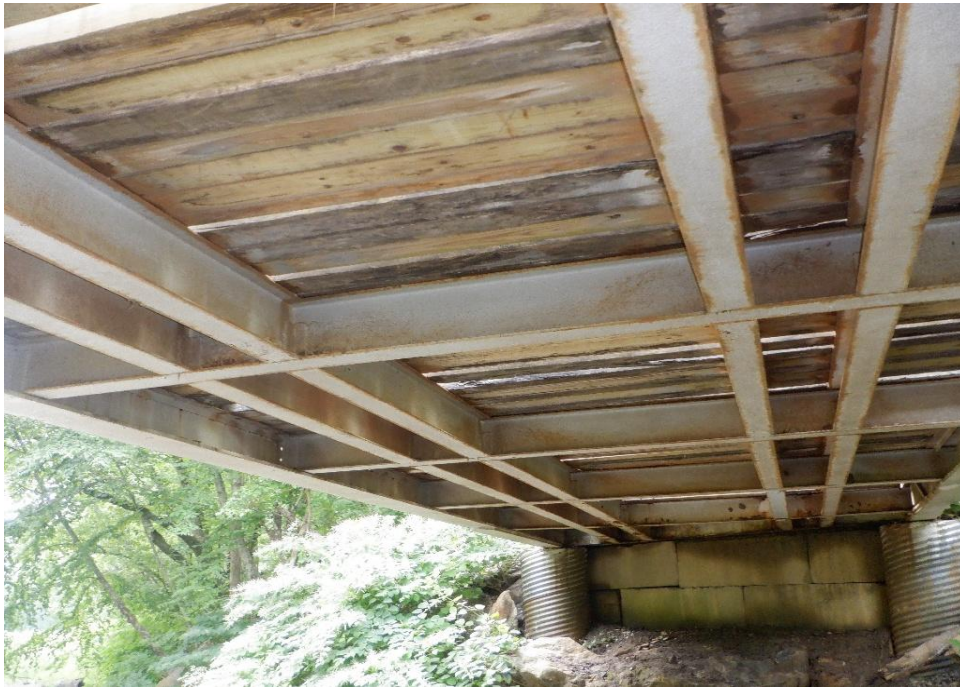
FB 5- PC FAILURE THROUGHOUT W/ CORROSION PRESENT

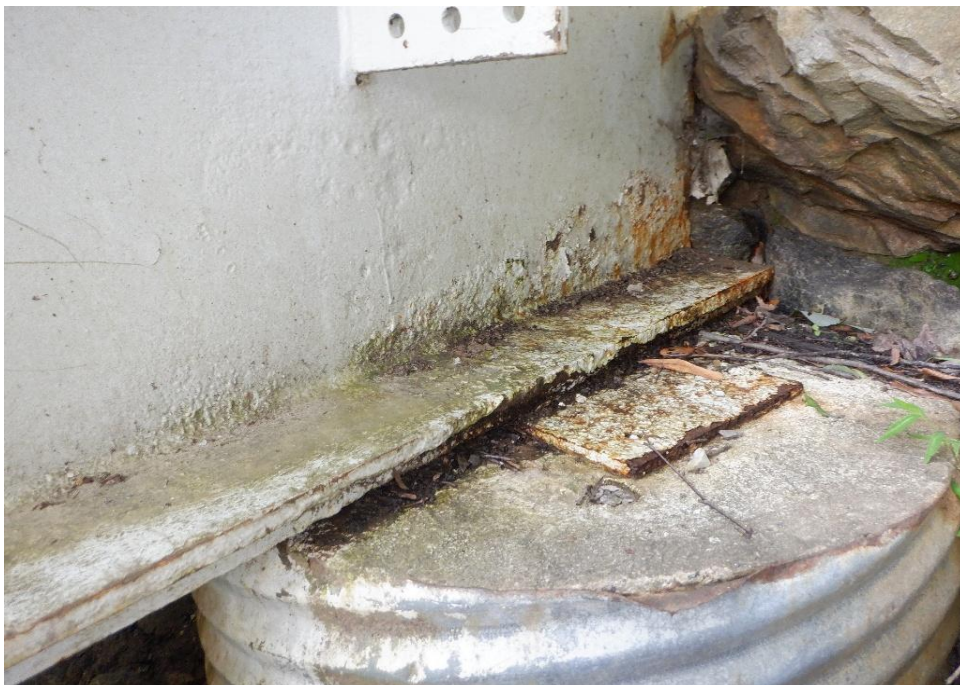
EB 2 GIRDER 2 BEARING/WEB PC FAILURE & CORROSION PRESENT

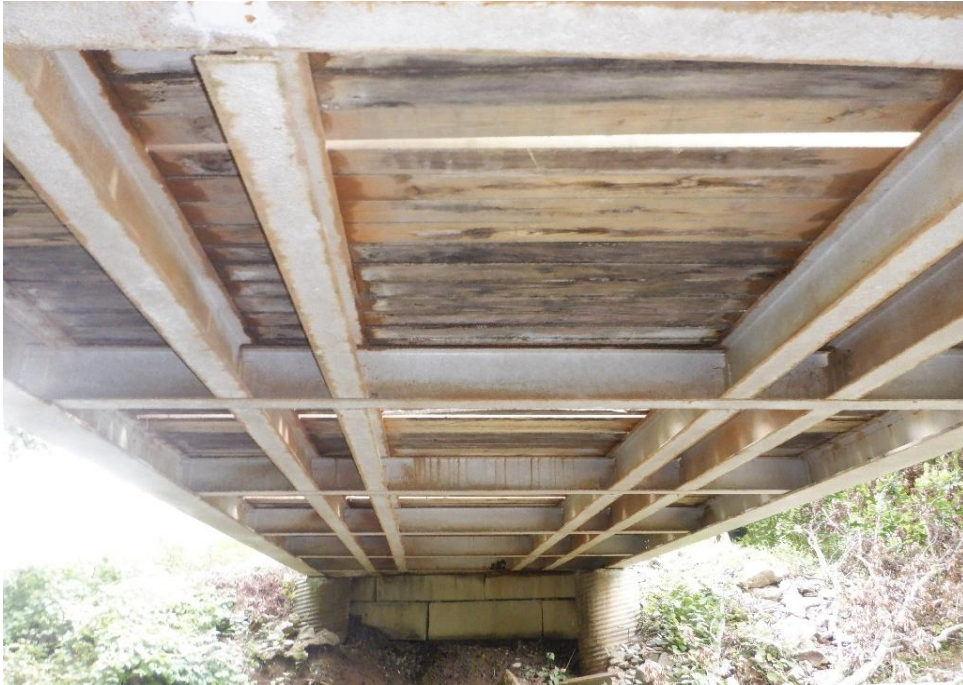
FB 6 - PC FAILURE THROUGHOUT W/ CORROSION PRESENT

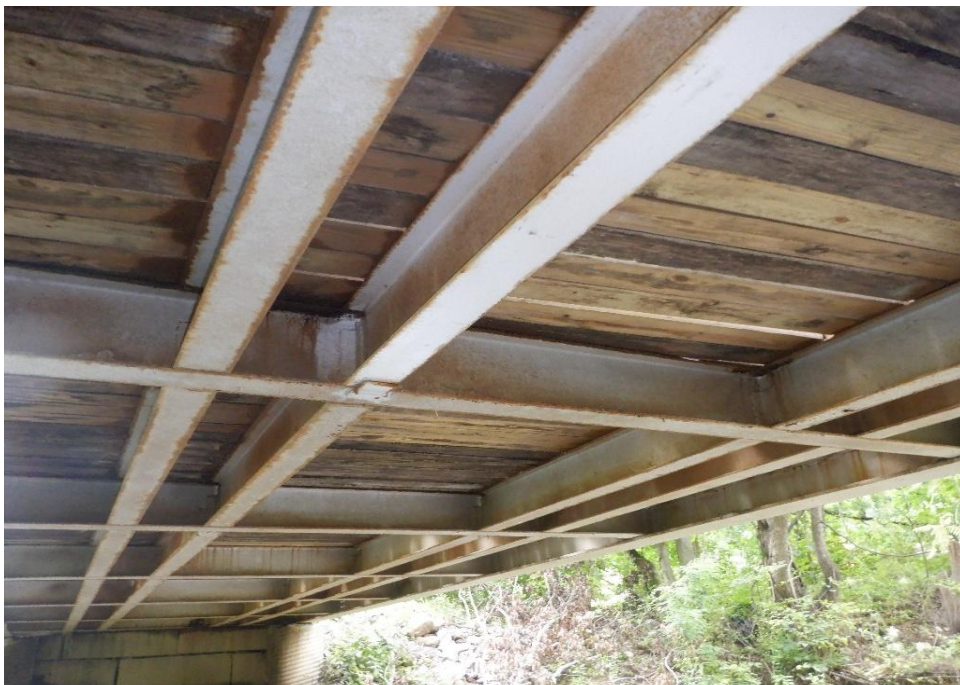
FB 7 PC FAILURE THROUGHOUT W/ CORROSION PRESENT

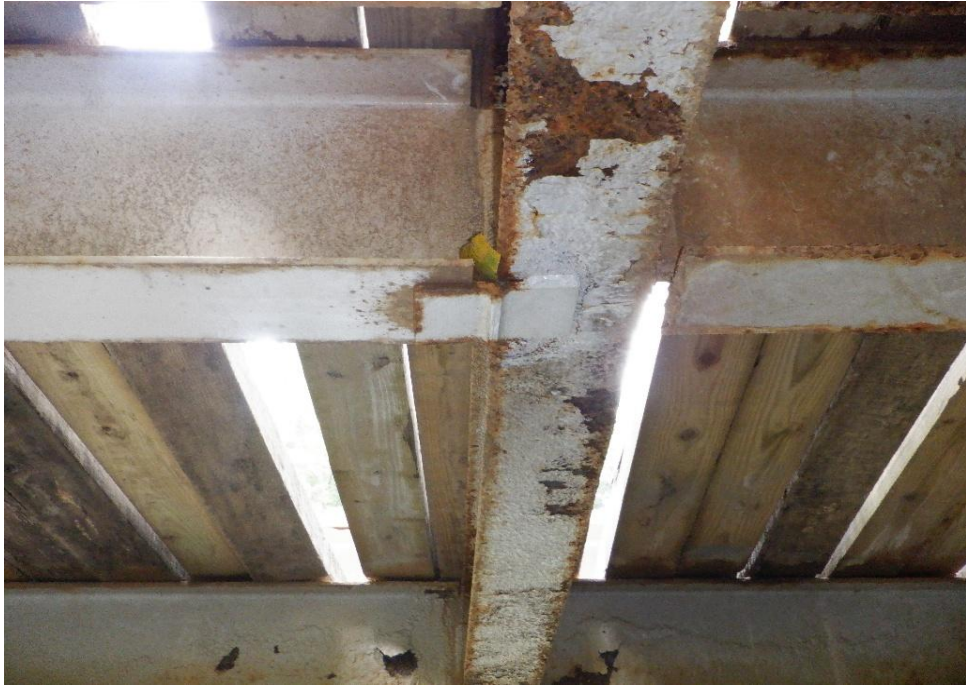
FB 8 ACTIVE CORROSION W/ 1/8" PITTING FULL LENGTH
