CAROLINA INFRASTRUCTURE ASSESSMENT LLC.  
STRUCTURES DIVISION

## Structure Safety Report

### Routine Element Inspection

| Superstructure: | STEEL STRINGER, TWIN GIRDER SINGLE SPAN BRIDGE W/ TIMBER DECK | | | | | |

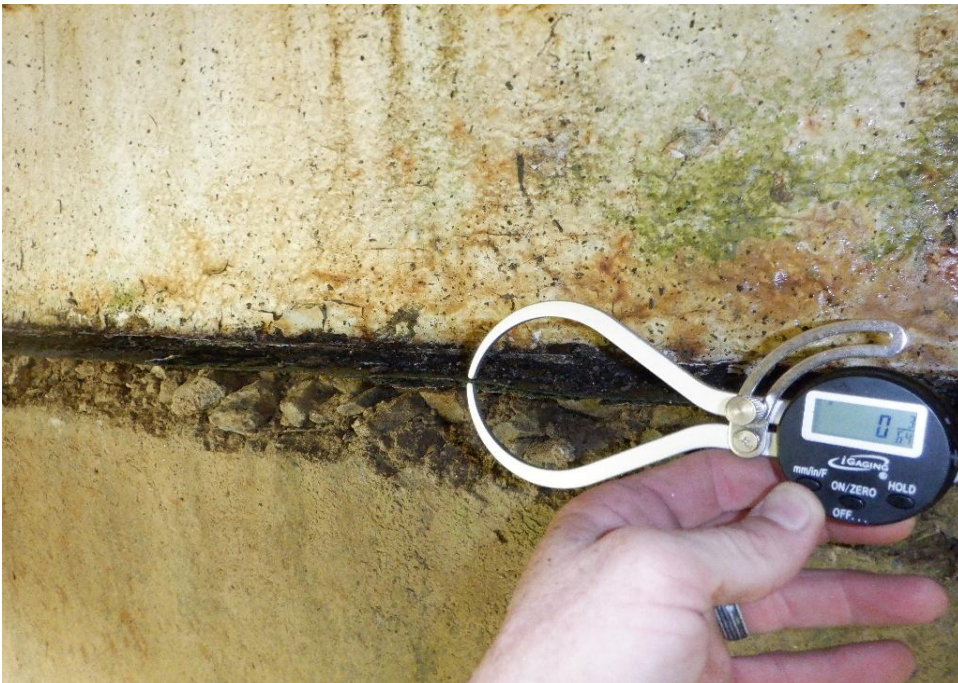
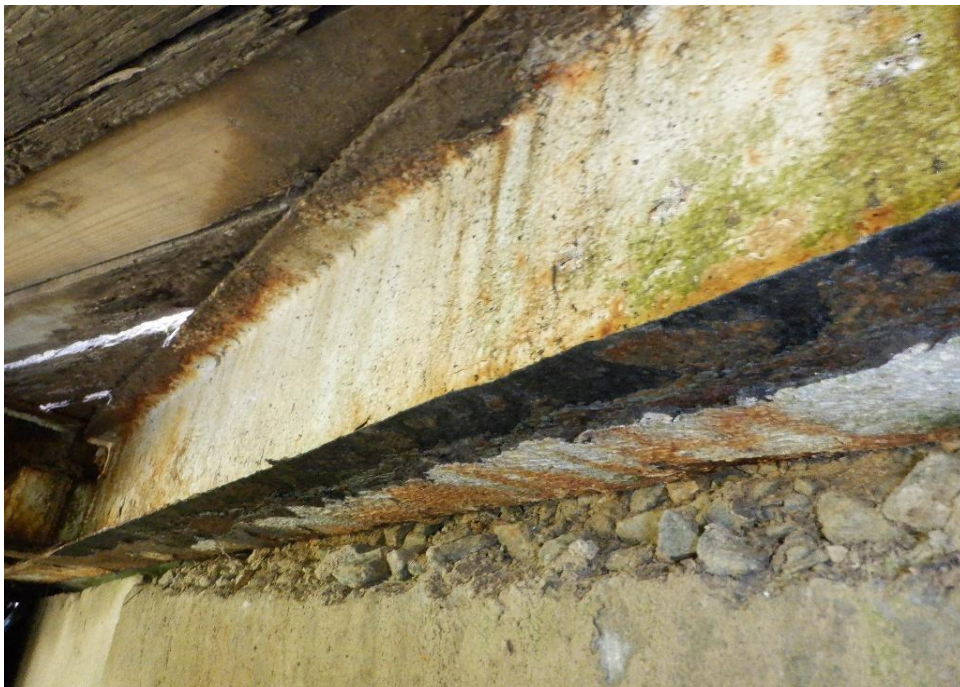
FB 9 3/64" REMAINING TO BOTTOM FLANGE FULL LENGTH

FB 9 OVERVIEW BOTTOM FLANGE 3/64" REMAINING

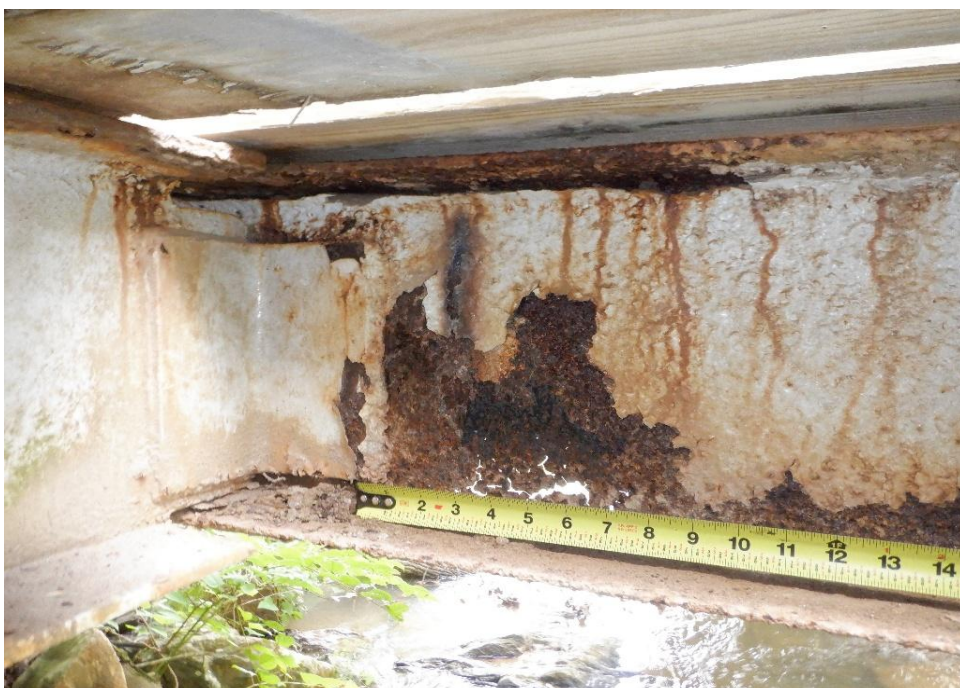
FB 8 6"X4" HOLE IN WEB BTW STR 2/3

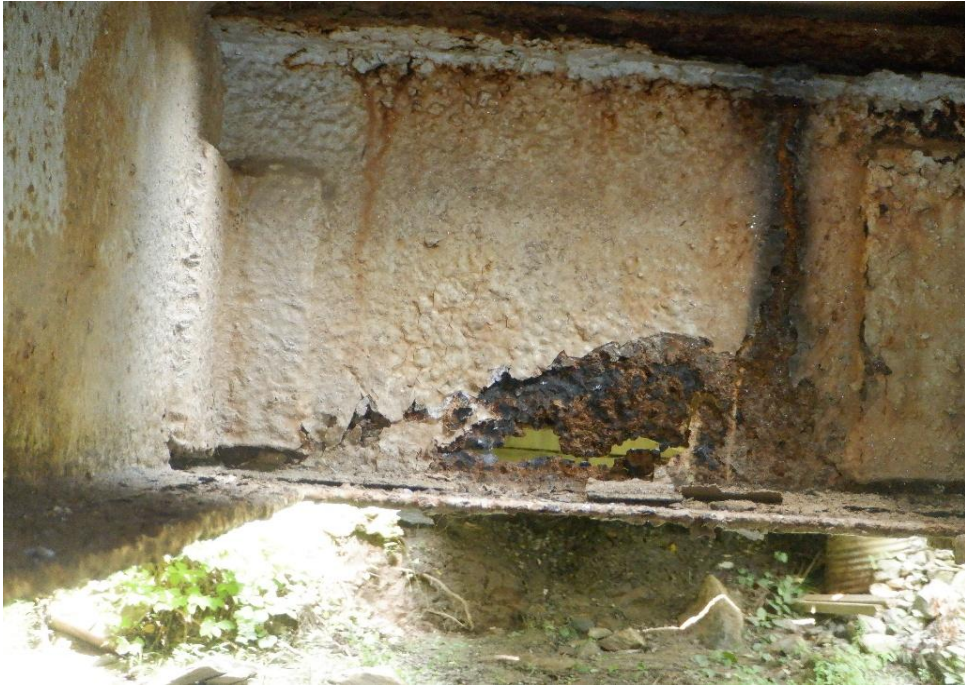
FB 8 - 5"X3" HOLE IN WEB BTW STR 3/4

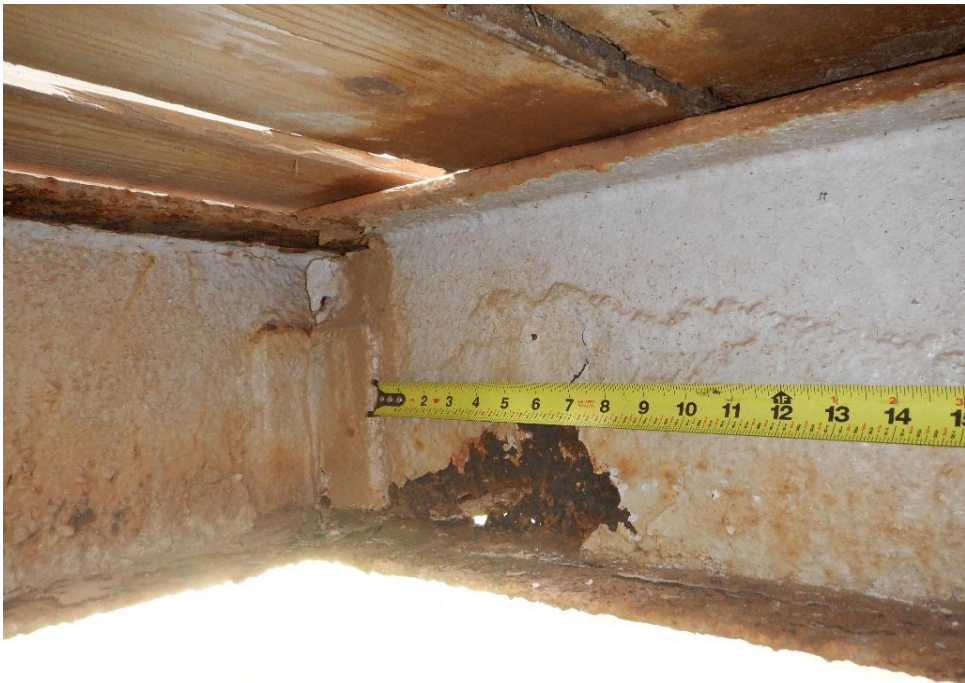
STR 2 - 7"X3" HOLE IN WEB BTW FB 8/9

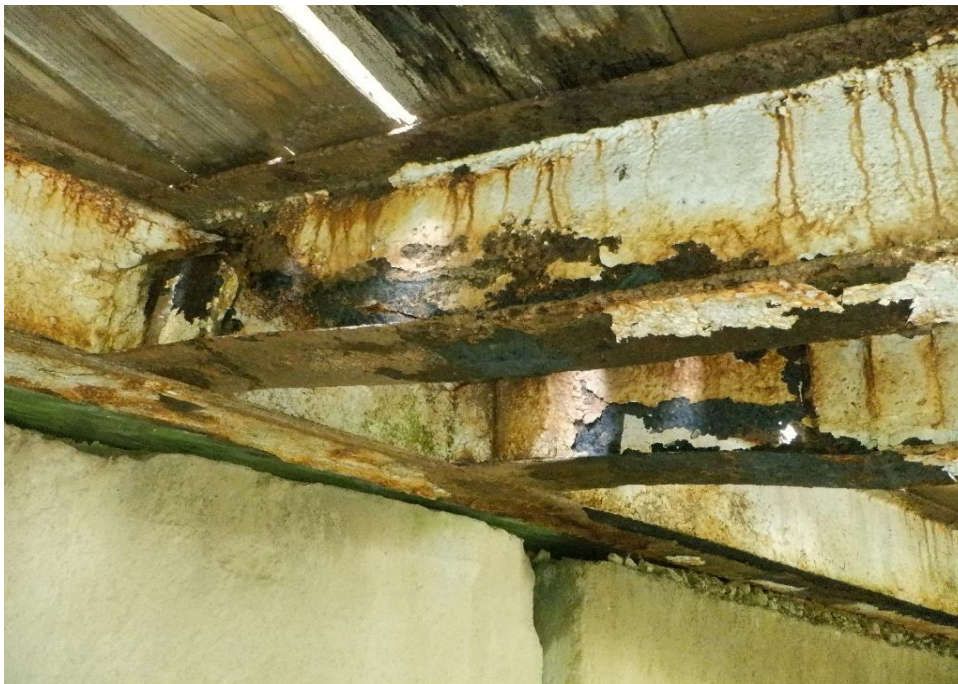
STR 1 - 16"X8" HOLE IN WEB; BUCKLING AT FB 9 JUNCTION - PAR  
3/8" REMAINING TO BOTTOM FLANGE

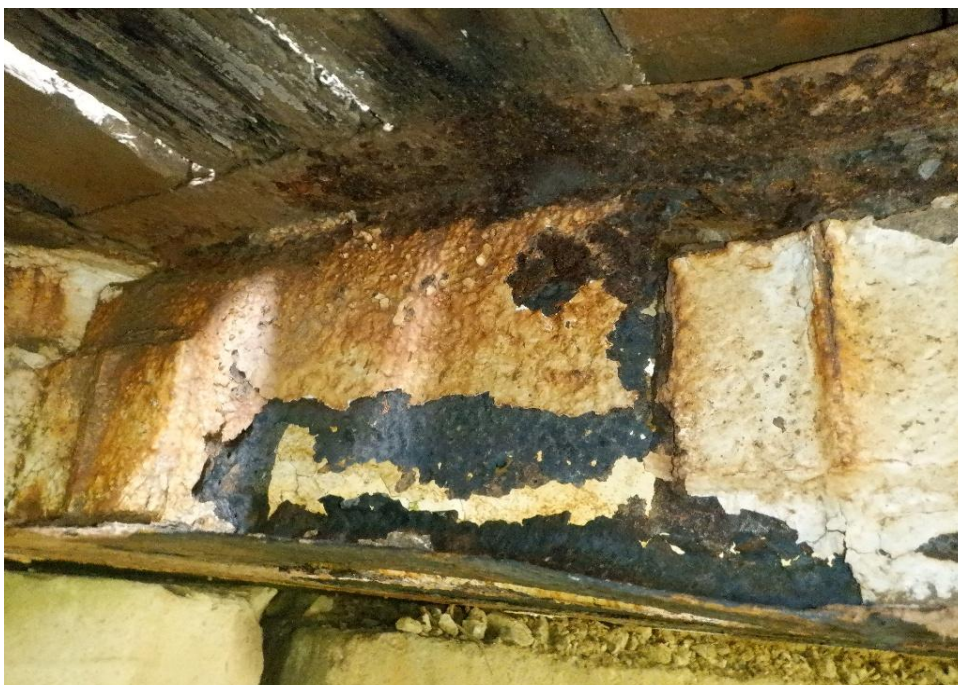
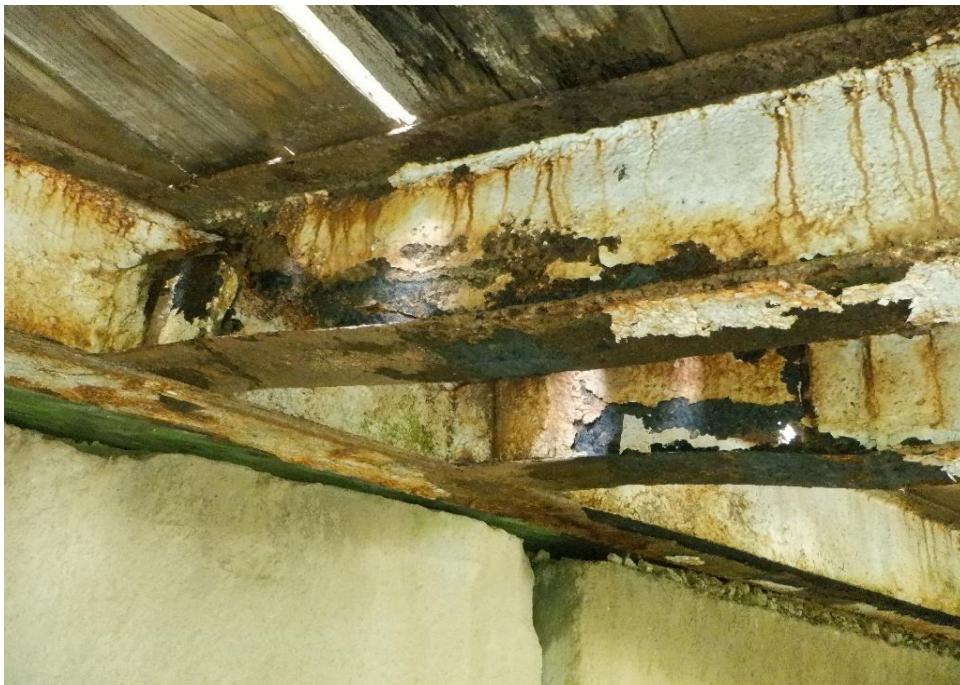
STR 2 - 1'X10" HOLE IN WEB; BUCKLING AT FB 9 JUNCTION - PAR  
5/16" REMAINING TO BOTTOM FLANGE

ALT. VIEW-STR 2 - 1'X10" HOLE IN WEB; BUCKLING AT FB 9 JUNCTION - PAR  
5/16" REMAINING TO BOTTOM FLANGE

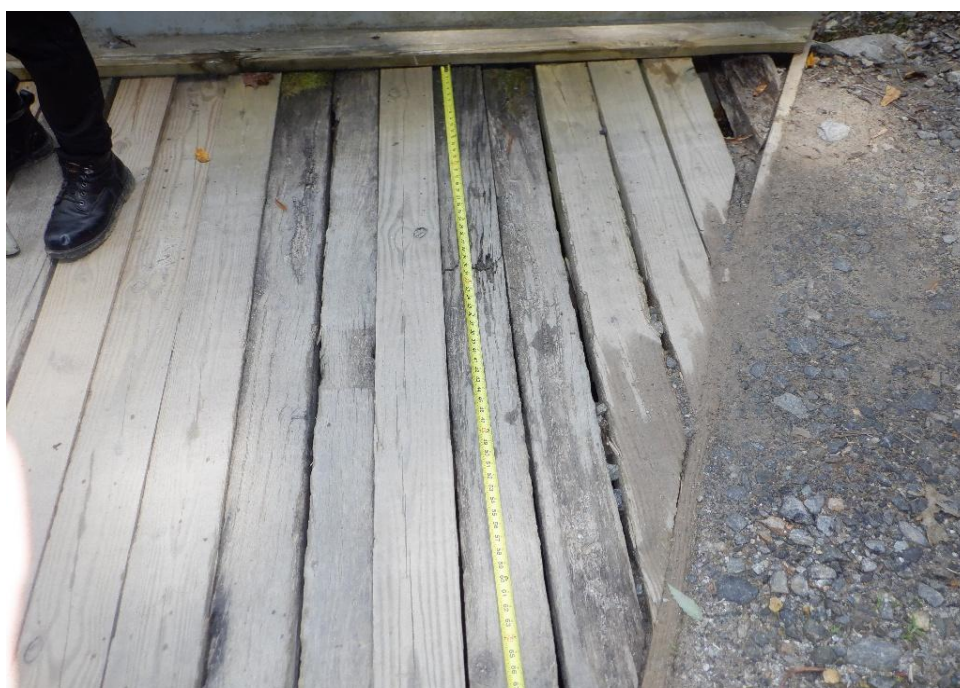
2 DECK BOARDS OVER STR 1/2 DECAYED OVER EB 2
